Figure 10
PAPUA NEW GUINEA
SOLWARA 11i SMS SYSTEM - XRF RESULTS

12 January 2010 © Nautilus Minerals

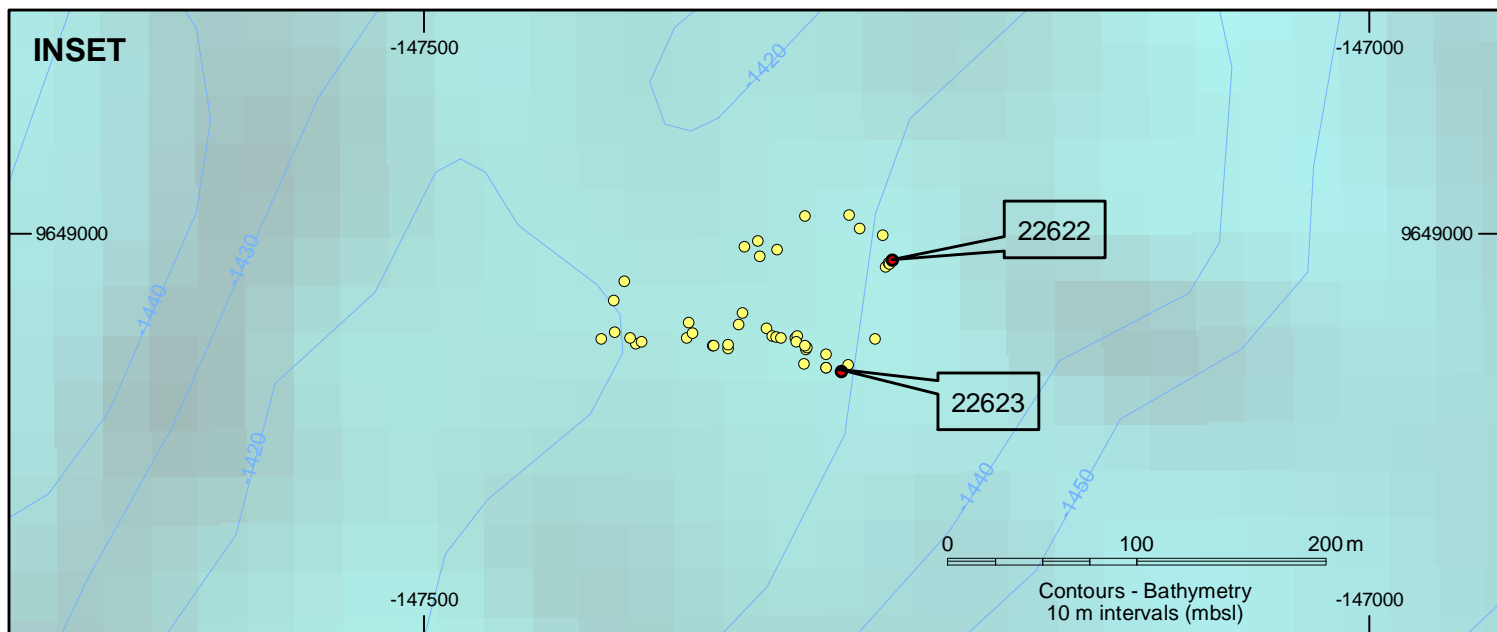
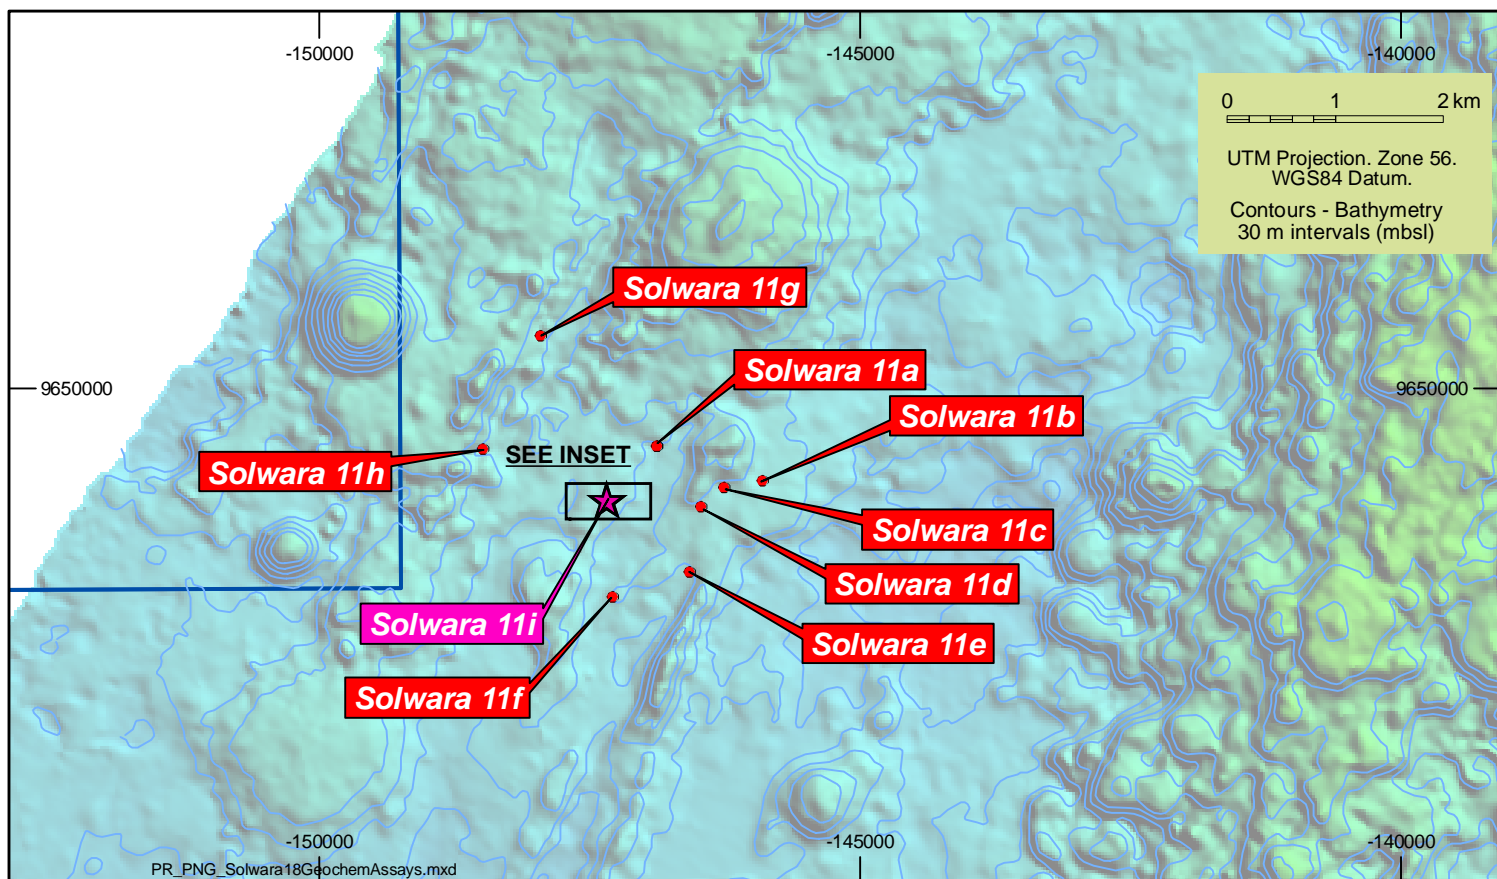
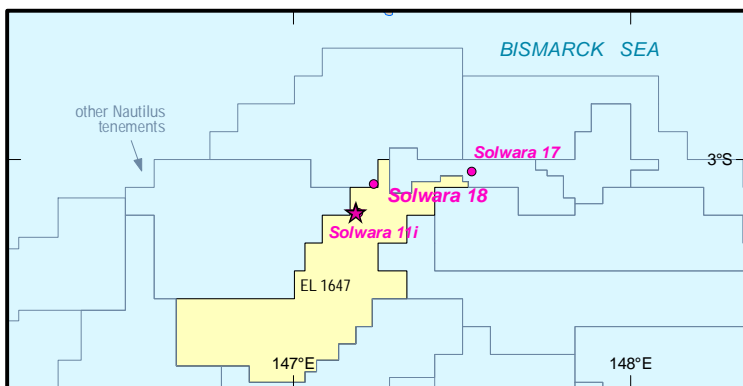
- ★ Solwara 11i
- Solwara 11 SMS Sub-systems
- Observed chimney or chimney talus
- Sulphide grab sample

XRF ANALYSIS RESULTS
 (sulphide samples)

Sample	Cu%*	Zn%*
22622	0.9	35.4
22623	1.2	20.4
Average	1	27.9

* Average of 10 analyses per sub-sample using hand-held XRF
